PHASE I ENVIRONMENTAL SITE ASSESSMENT
for
2455 Third Avenue
The Bronx, New York
Lot 2319, Lots 37 and 155

June 2019
Langan Project No. 190051701

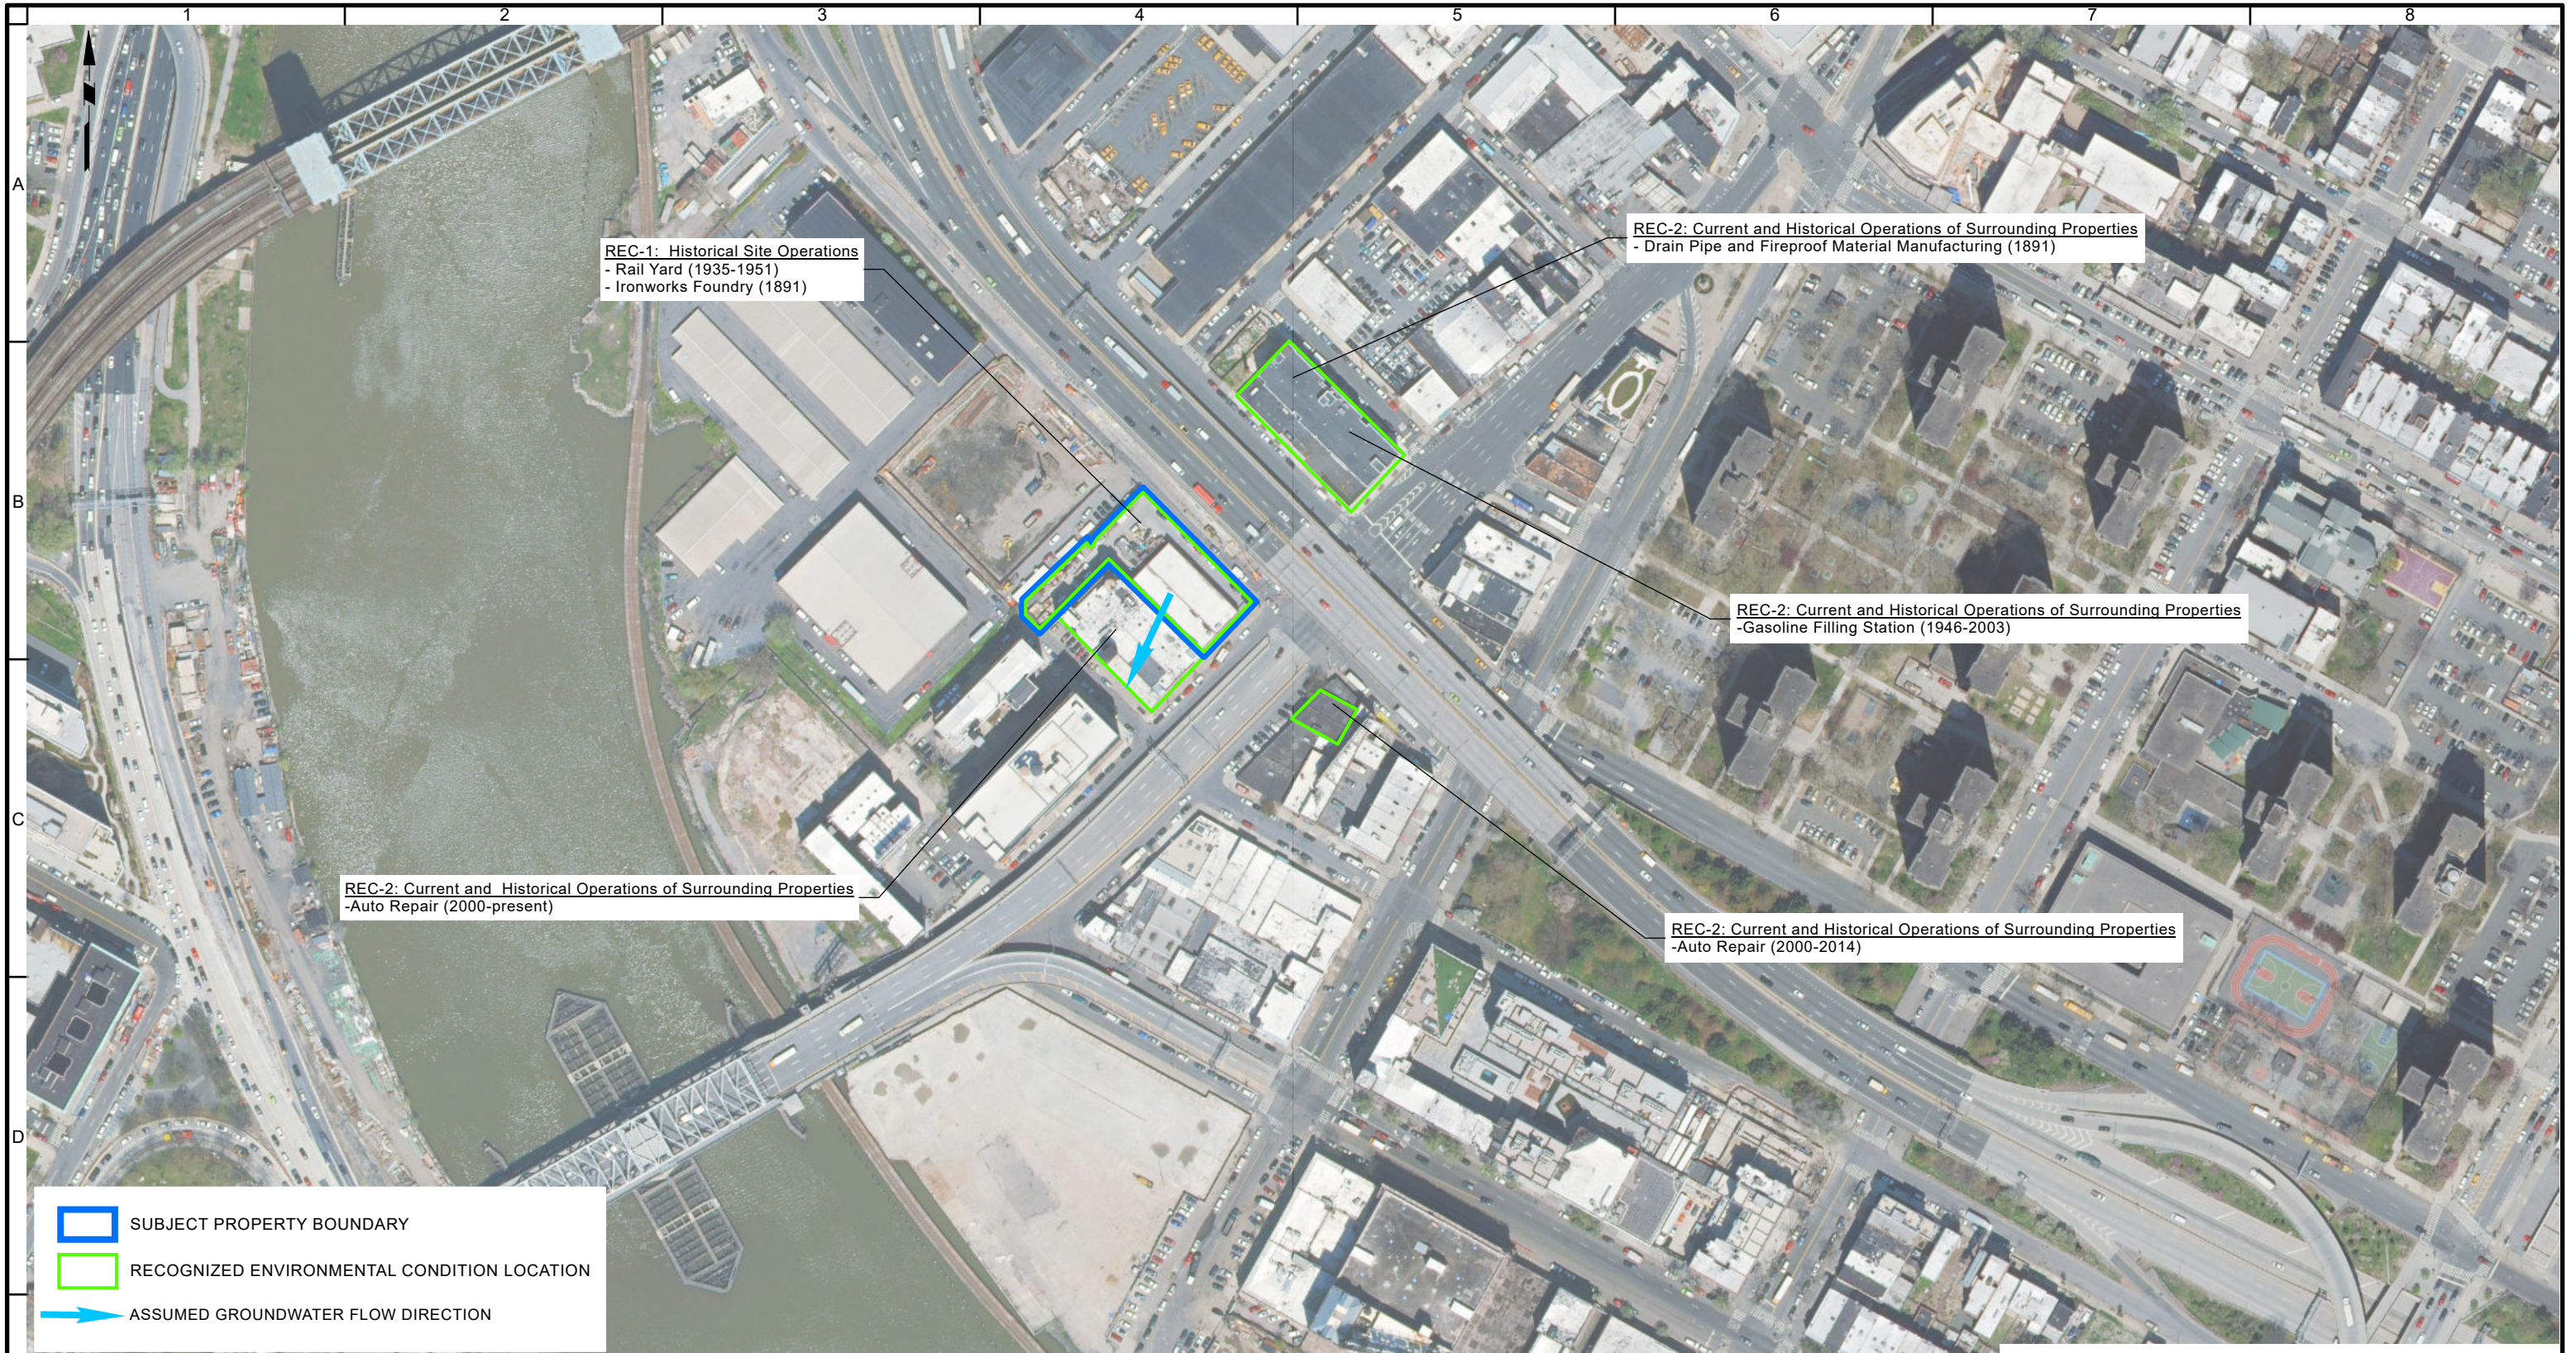
Drawing Title
RECOGNIZED ENVIRONMENTAL CONDITION MAP

REC 1 – Historical Site Operations

The Subject Property was operated as a rail yard between 1935 and 1951 and iron works foundry in 1891. Activities associated with the iron works foundry and treated rail ties from the rail yard may have resulted in releases of Polychlorinated Biphenyls (PCBs), metals, or hazardous materials that impacted the soil, soil vapor and/or groundwater at the Subject Property. Treated rail ties may still exist at the Subject Property and may need to be disposed of during future construction.

REC 2 – Current and Historical Operations of Surrounding Properties

The adjoining up-gradient properties to the northeast were historically used as a filling station (1946-2003) and a drainpipe and fireproof material manufacturing facility. The adjoining cross-gradient property to the southeast was an auto repair (2000-2014). An adjacent property located about 150 feet to the southwest is an auto repair (2000-present). Migration of contaminants from these adjoining and surrounding properties have the potential to impact the soil vapor and/or groundwater at the Subject Property.

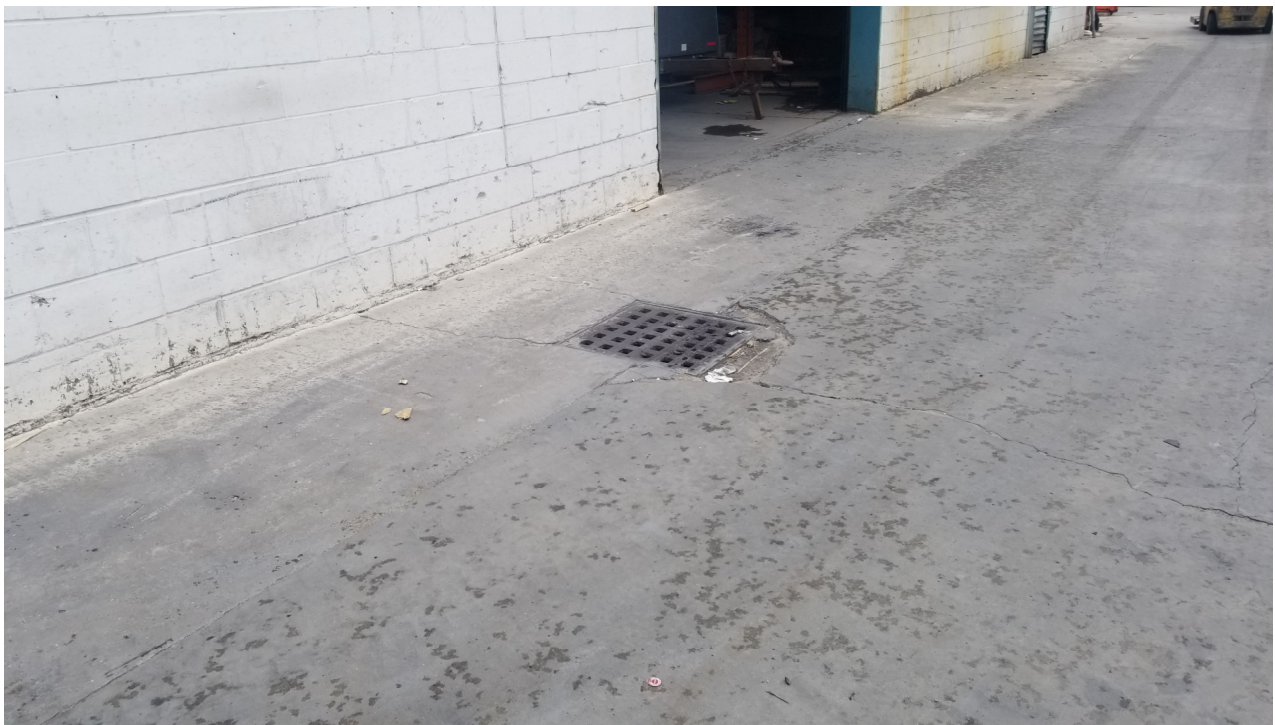
Three storm drains were observed in the material storage/parking area to the north and east of the building. One damaged storm drain grate in the northern parking area was covered with three metal plates. No staining was observed surrounding the storm drains.

Photograph 10: View of stormwater inlet in concrete parking area along 135th Street, facing north.

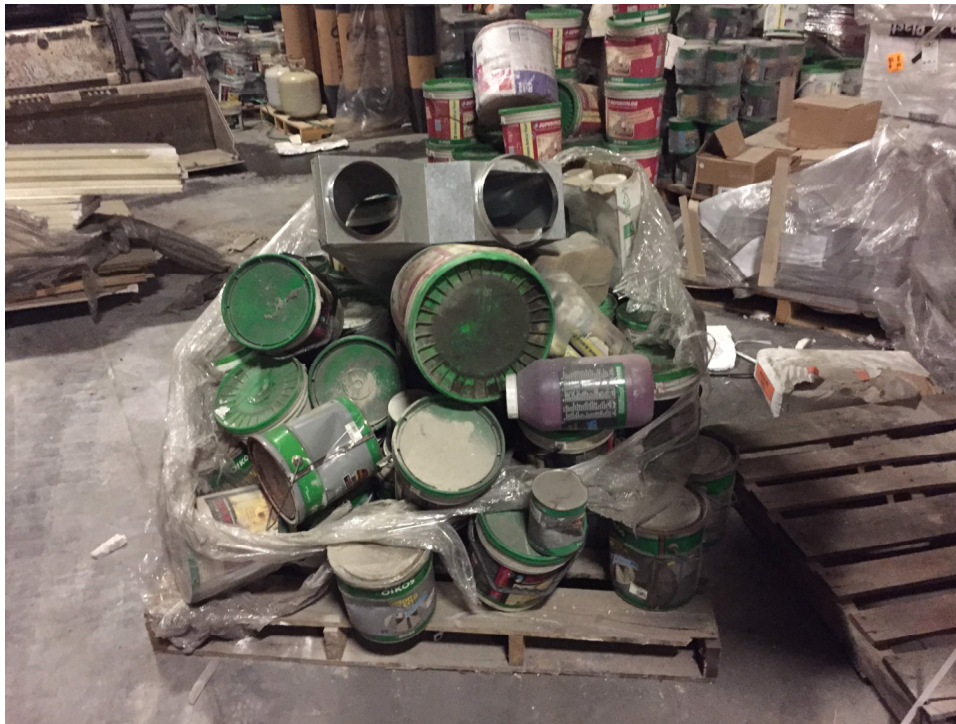
Photo 15: General view of chemical storage in the warehouse, facing north.

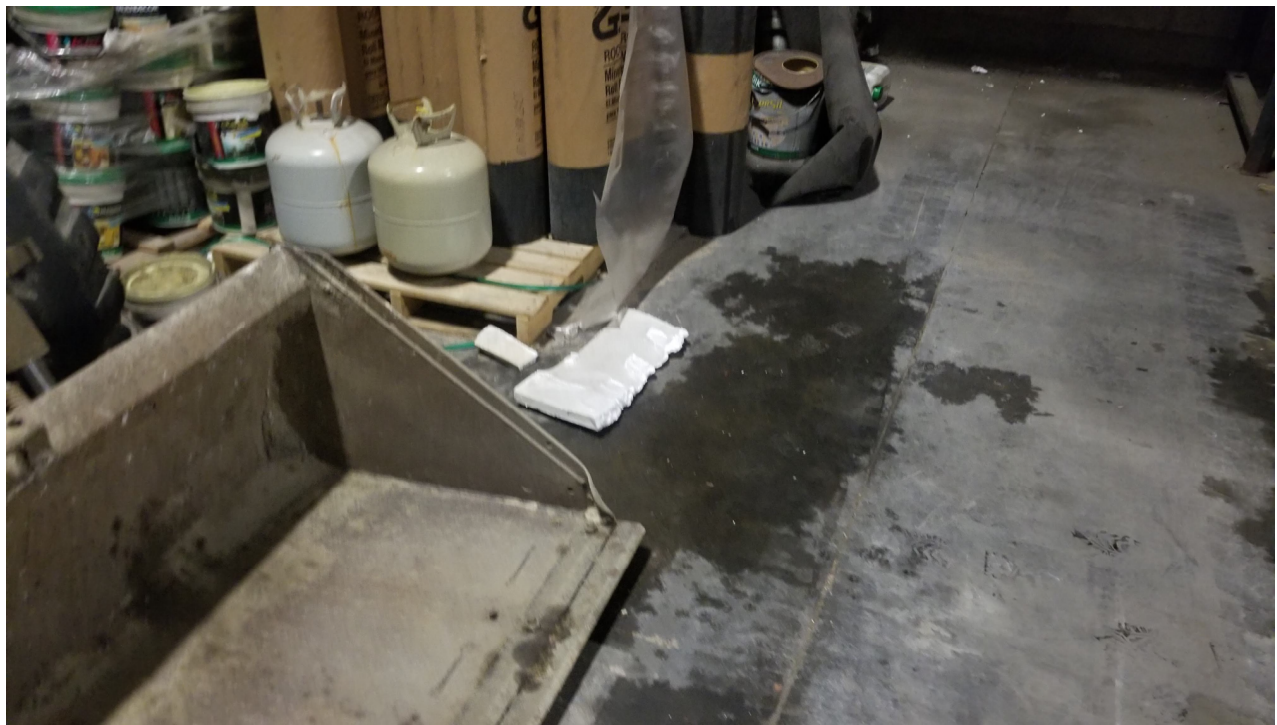
A small area of staining was observed on the floor of the western side of the warehouse. The stain was on concrete, which was observed to be in good condition with no cracks or breaches.

One de minimis condition, staining in the western warehouse, was observed. Due to the small area of the stain and the integrity of the concrete beneath, this staining represents a de minimis condition.

Photograph 16: View of de minimus staining observed within the warehouse.
